# Identification of possible structural defects on piled foundations supporting structures on permafrost soils: Norilsk's Palace of Culture case study

## ABSTRACT

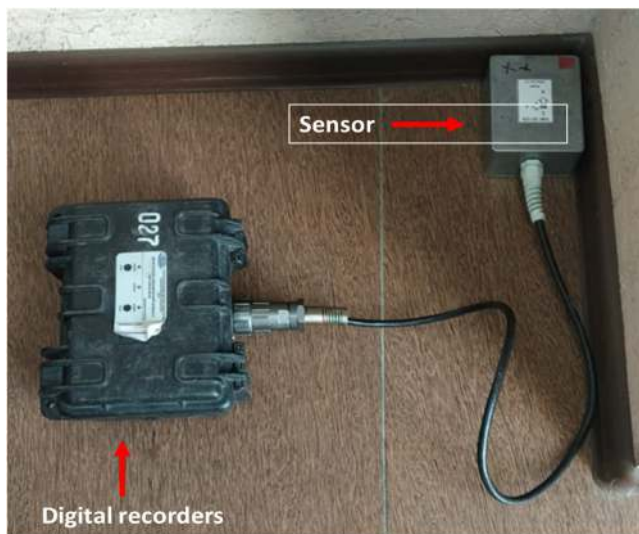
Fig. 6. The recording process on the first floor of the surveyed structure using the Baikal-7 recorder and a three-component GD-10 sensor.

In the second stage of the work, the spatial distribution of the amplitudes of the natural vibrations from the lowest modes of the building foundation was constructed. The work was carried out using Baikal-7 seismic recorders and three-component GD-10 sensors with a natural frequency of  $5$  Hz (Fig. 6).

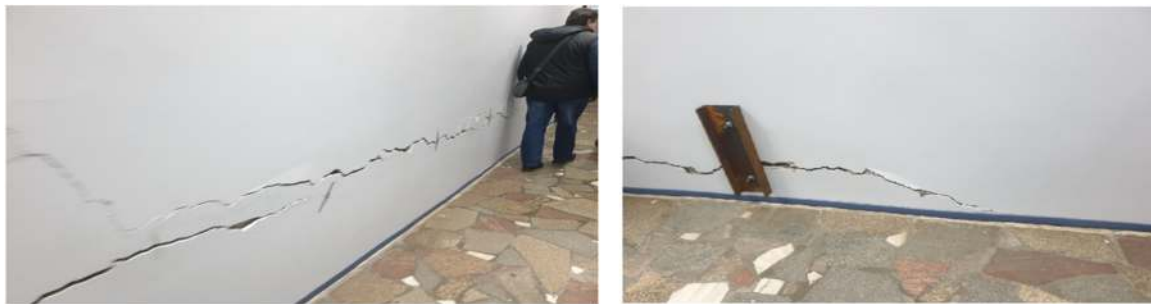
Fig. 12. Examples of cracks on the ground floor (Location highlighted in plan).

Cracks are observed in many areas of the building with high natural vibration amplitudes (Fig. 12).
