# Assessment of the technical condition of the Sukhumi Lighthouse, Abkhazia using passive seismic standing waves method

The results of a geophysical survey of the technical condition of the lighthouse are presented. The stress–strain state, the residual resource, the tension of the fastening cables, the fixation of piles in the ground (rigid/non-rigid), and the immersion depth of the historical study object, the Sukhumi Lighthouse built in 1861 were determined. The passive seismic standing method based on the extraction of the natural vibrations of the object from noise records, as well as the tapping method, based on the recording of a reflected seismic wave passing along the structure were used to solve the above problems.

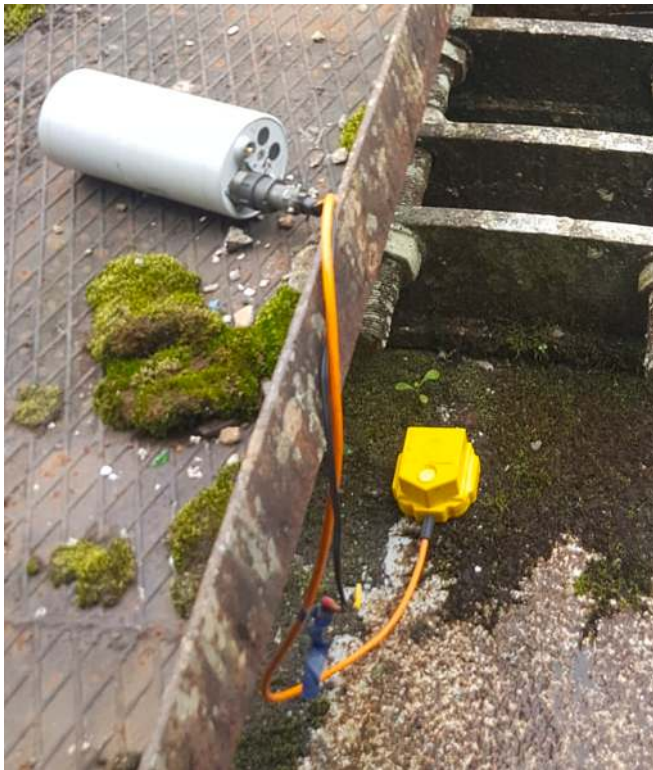
**Fig. 1.** Baikal – 1 recorder and sensor – (yellow). (For interpretation of the references to colour in this figure legend, the reader is referred to the web version of this article.)

All passive seismic measurements were made using Baikal-1 recorders and sensors with a natural frequency of 5 Hz, recording transverse, longitudinal and vertical vibrations (Fig. 1.).

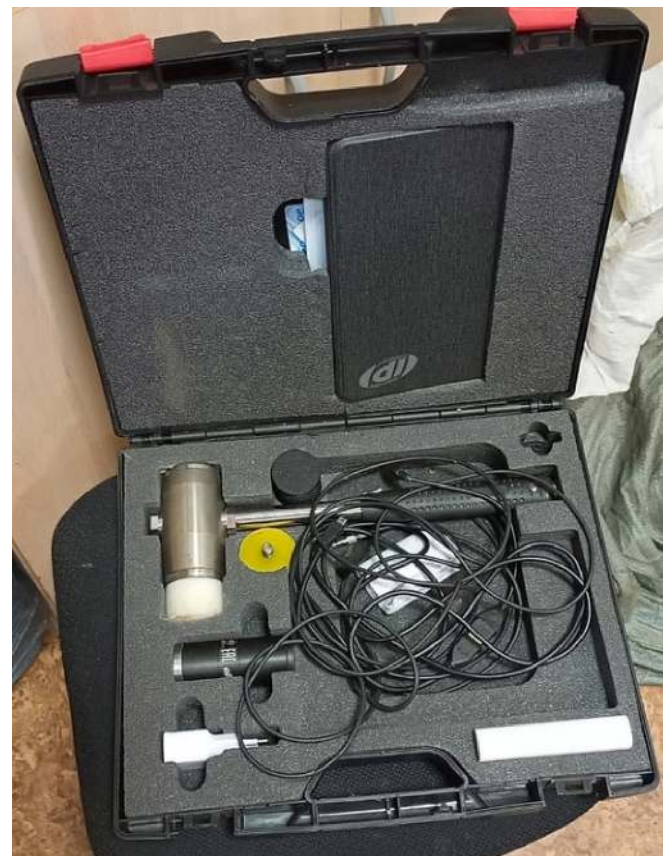
**Fig. 4.** A set of measuring equipment "Spectrum 4.3".

During the measurements, the Spectrum 4.3 equipment was used (Fig. 4), which is a set of a hammer, an oscillation sensor, and a tablet with software that allows for primary processing.

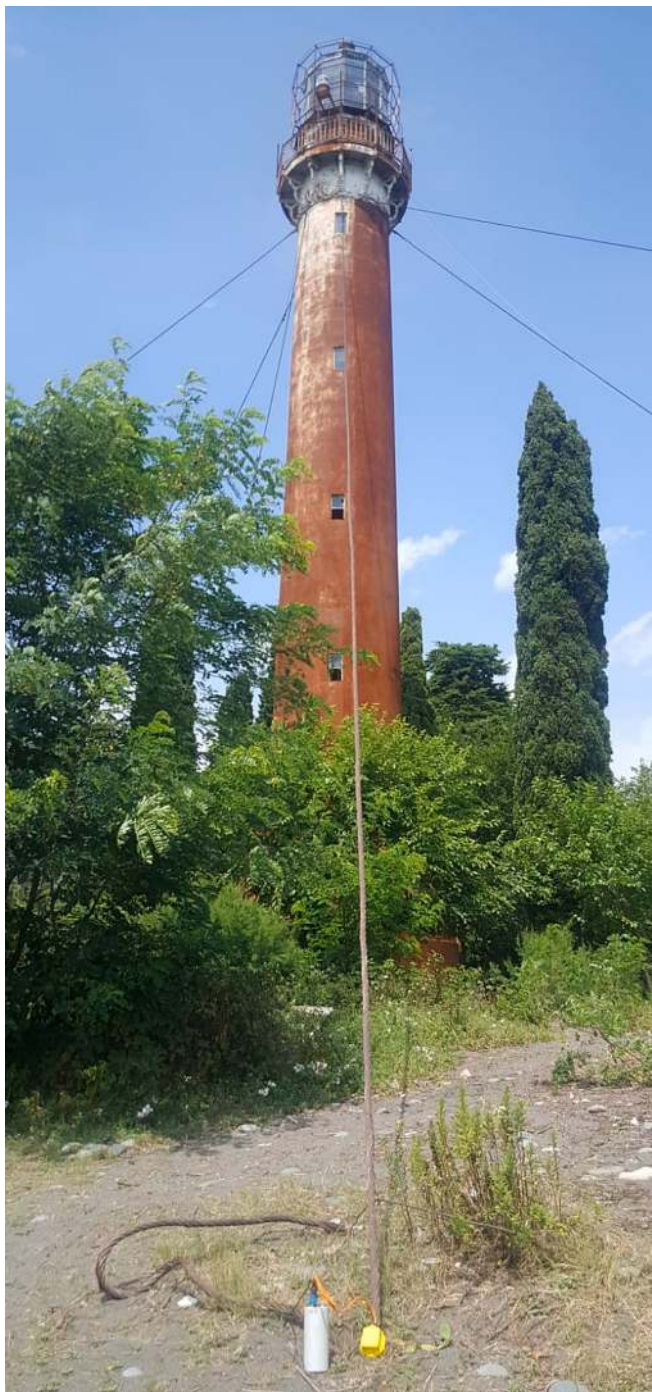
Fig. 5. Sukhumi Lighthouse.

The study object was the Sukhumi Lighthouse, built in 1861 on the Black Sea coast (Fig. 5). Since its construction, the structure has lost stability, tilted, and is supported by 6 stretched cables. In addition to the cables, the lighthouse rests on 8 piles. The height of the object is about 35 m.
